**U.S. ARMY ENGINEER RESEARCH AND DEVELOPMENT CENTER:
RAPID REPAIR OF LEVEE BREACHES**

Donald Resio, Stanley Boc, Donald Ward, Andrew Kleinman, and Jimmy Fowler
U.S. Army Engineer Research and Development Center

Brian Welsh, Michael Matalik, and Phil Goodwin
Oceaneering International, Incorporated

June 2011

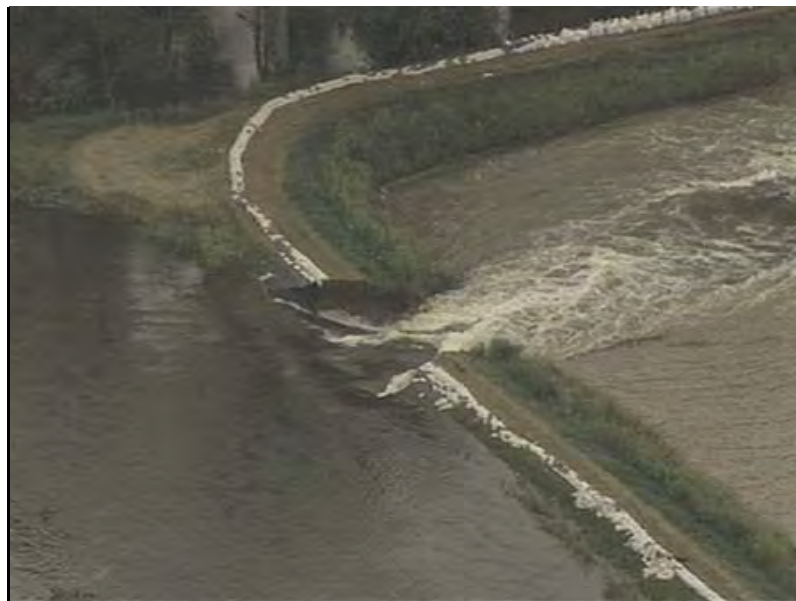
Figure 2.3. Failure of the Pin Oak levee in the Midwest. Note sand bags atop levee used to fight rising water levels.

Both natural and man-made levees have a long history of breaching in nature. Natural levees, built from sediment deposition when rivers overflow their banks, occasionally breach in what is termed a crevasse. Throughout the United States, failures of natural and man-made levees have resulted in lives lost, destroyed infrastructure, and huge economic losses. One example is the part of the Midwest containing the upper Mississippi River, Missouri River, and their tributaries. This area frequently experiences flood events that result in levee failures. Figure 2.3 shows a levee failure on the Pin Oak levee in the Midwest. Figure 2.4 shows the Elm Point levee break, also in the Midwest.

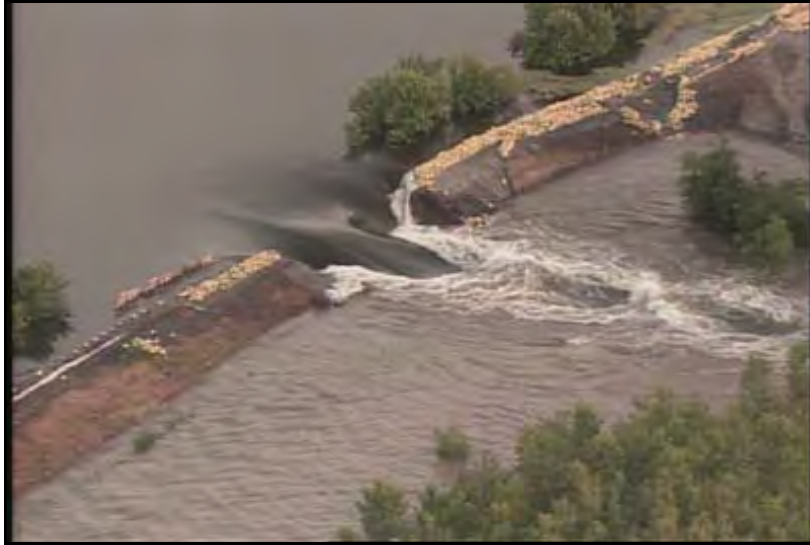
Figure 2.4. Failure of the Elm Point levee in the Midwest.

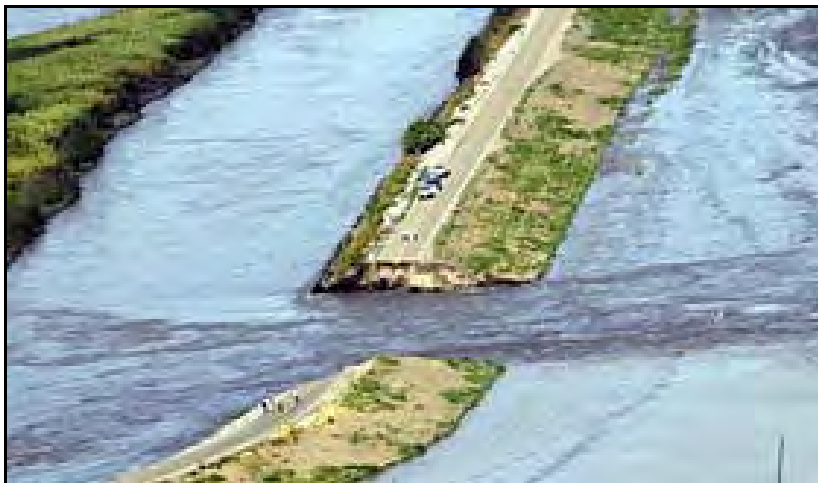
Figure 2.5. Upper Jones Tract levee breach in the Sacramento-San Joaquin River Delta.

Another area where levee failures are of great concern is the Sacramento-San Joaquin River Delta area. Major flood events occurred there in 1950, 1955, 1964, 1986, and 1997. Mount and Twiss (2004) report that the projected subsidence of the delta indicates that it will “become increasingly difficult and expensive to maintain the delta levee system.” Some areas of the delta are more than 8 m below sea level. This large amount of subsidence greatly increases the chance of piping-related levee failures, which will be discussed subsequently. Piping-related failures are the major concern in these levees. Figure 2.5 shows the 2004 breach in the levee at the Upper Jones tract in the Sacramento-San Joaquin River Delta.

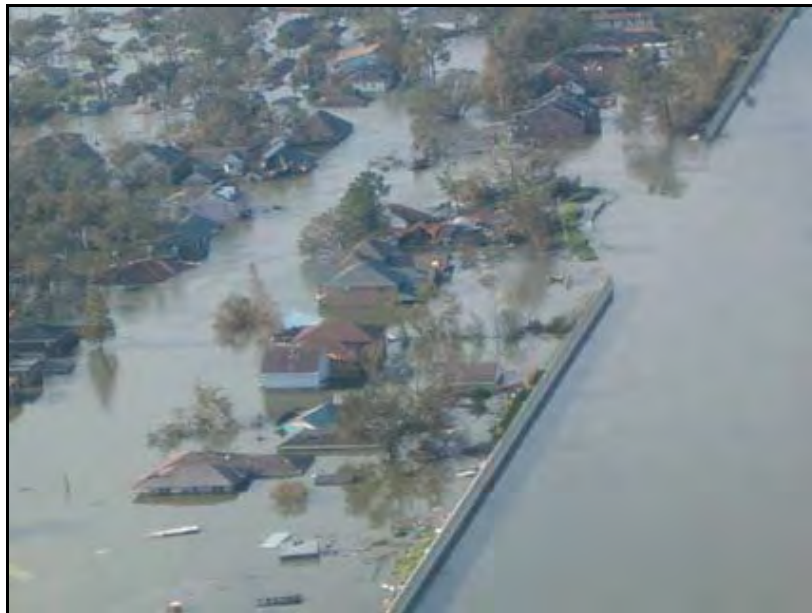
Figure 2.6. Floodwall failure on 17th Street Canal from Hurricane Katrina in New Orleans.

The current focus on levee breaches was brought about by the large number of levee and floodwall failures that occurred in the New Orleans area in 2005 as a result of Hurricane Katrina. The specifics of the failures are documented in the IPET report (IPET 2006). These failures became the most costly disaster in the history of the United States. During Katrina, levees and floodwalls failed as a result of most of the different causes discussed in this report. Figure 2.6 shows the floodwall failure on the 17th Street Canal.

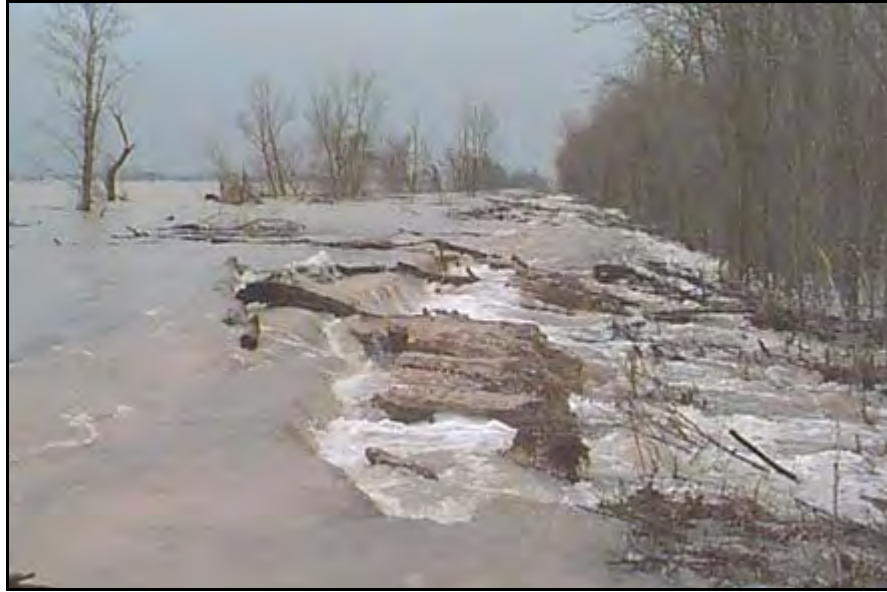
Figure 2.11. Overtopping of a levee over a wide area with a potential breach growing in foreground.

Overtopping- Overtopping occurs when the water level in the river exceeds the crest of the levee or waves spill over the levee. Because of the relatively steep landside slopes of many levees, such as those shown in the previous levee cross sections, once they are overtopped, the water moves rapidly down the land side of the levee. If the height and duration of overtopping is small and the slope is covered by a good layer of grass or other protective material, the levee can survive overtopping. For large heights and durations of overtopping and no landside slope protection, a breach is likely to occur. The overtopping flow will find a locally low or locally weak spot at which erosion is initiated. Once erosion has been initiated, the flow tends to concentrate the erosive forces and the breaching process accelerates. The stages of breach formation will be discussed subsequently. The Scientific Assessment and Strategy Team (SAST) reported that eyewitness accounts indicate that the majority of levee breaches during the 1993 flood on the Missouri River were caused by overtopping (SAST 2007). Wave overtopping and breaching of the levee is similar to overtopping from excessive river water level except that an RRLB technique may have to be placed in waves and withstand wave forces. Figures 2.11 and 2.12 show overtopping over a wide area of a levee along a river.

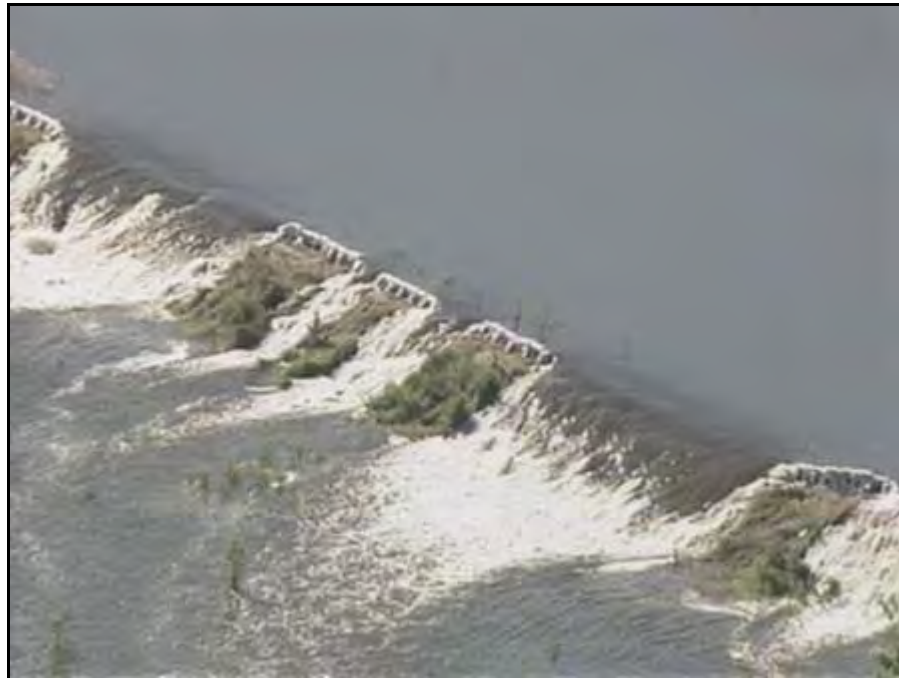
Figure 2.12. Overtopping of the Foley levee in the Midwest.

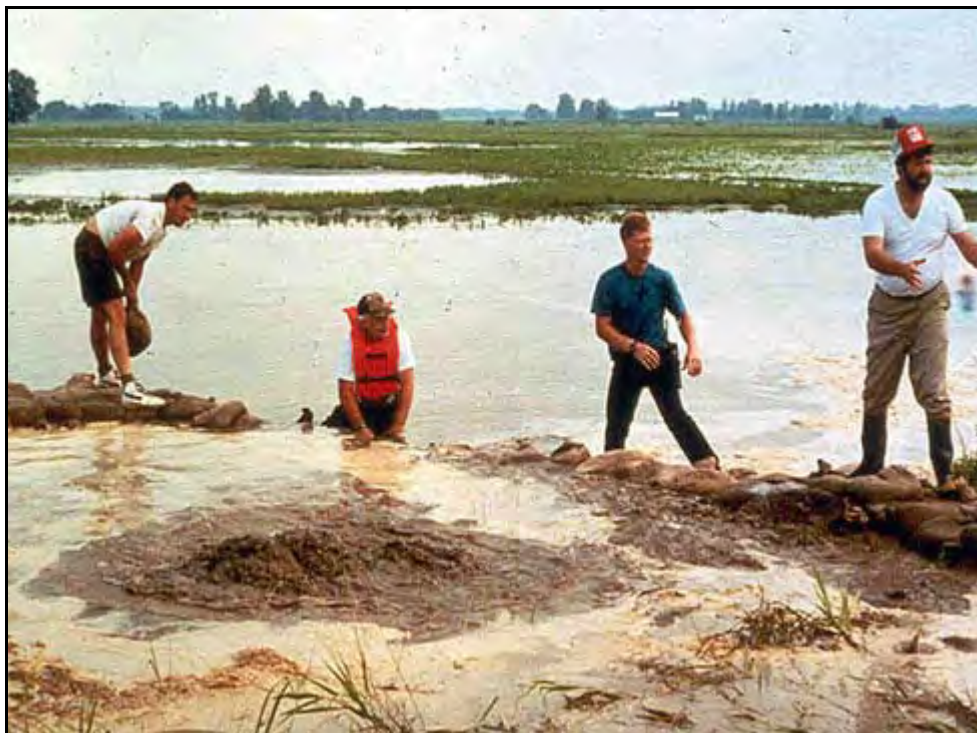
Figure 2.13. Sand bag levee around sand boil on Kaskaskia River.

Figure 2.13 shows a ring levee of sand bags around a sand boil on the Kaskaskia River levee. Ring levees are one of the existing rapid repair techniques that have been used for many years with great success. Ring levees are placed only to the level that stops movement of sediment with the water. If placed to a greater height to stop flow, the increased head will likely result in the piping connection blowing out somewhere else. Before this picture was taken, the ring levee had reduced the flow and stopped the movement of solid material. Suddenly the levee foundation material started moving again as shown in the figure. Efforts to further raise the sand bag levee and stop the material movement were unsuccessful and the full breach formed as shown in Figure 2.14.

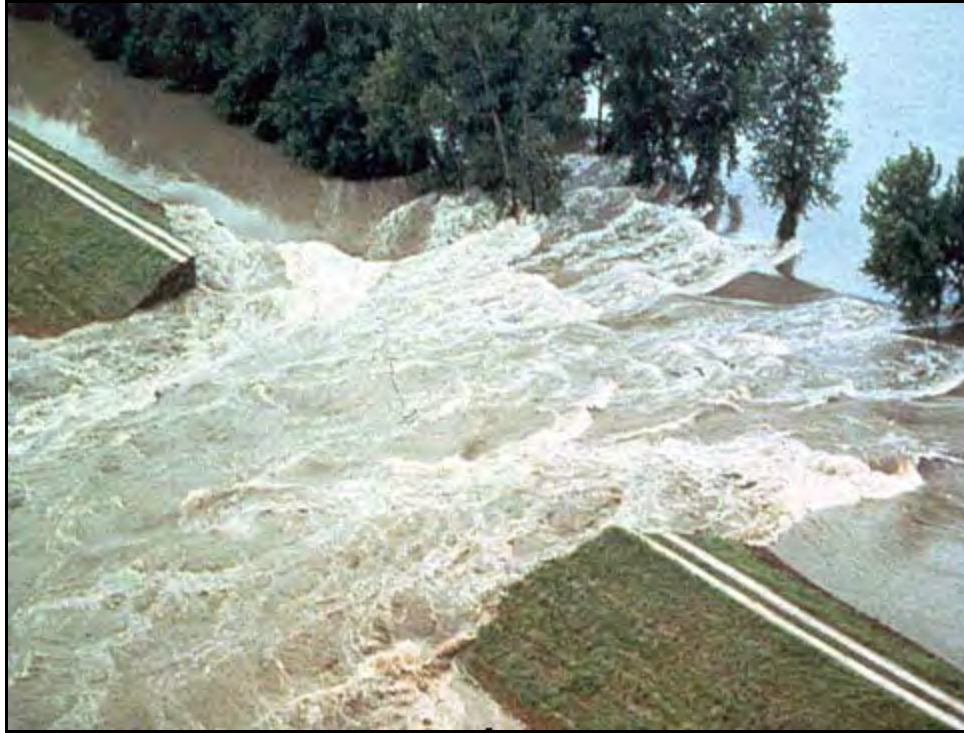
Figure 2.14. Kaskaskia River levee breach at location of sand boil.

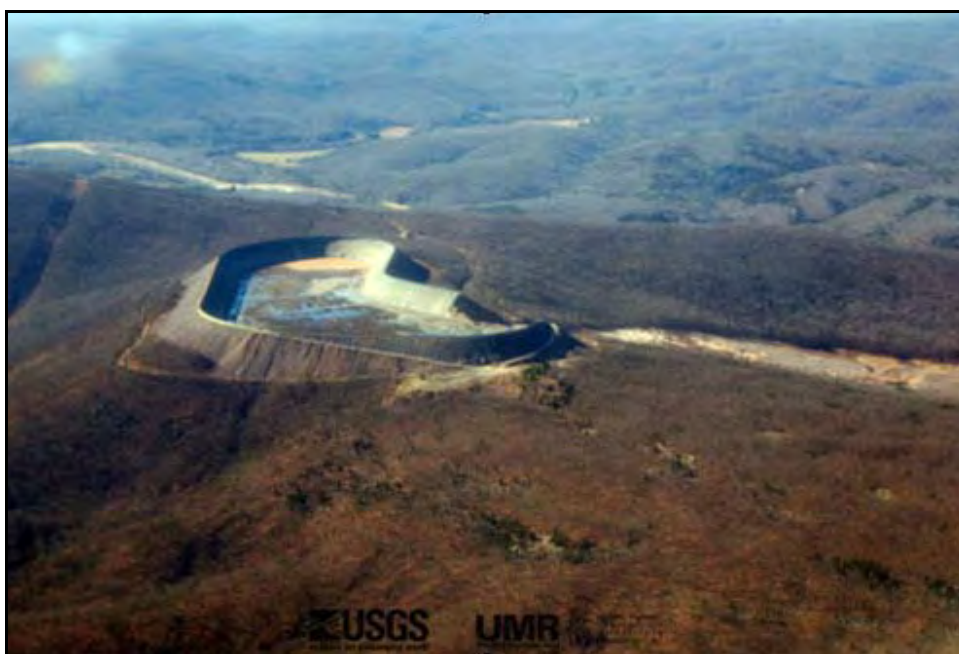
Figure 2.17. Aerial photo of the Taum Sauk Upper Reservoir just after breach in December 2005.

Normally a breach forms slowly by overtopping, scouring, or piping; but that is not always the case as exemplified by the failure of the Taum Sauk Upper Dam, Missouri, in December of 2005. Figure 2.17 shows a general view of the Taum Sauk Upper Reservoir near Ironton, Missouri, just after the breach.

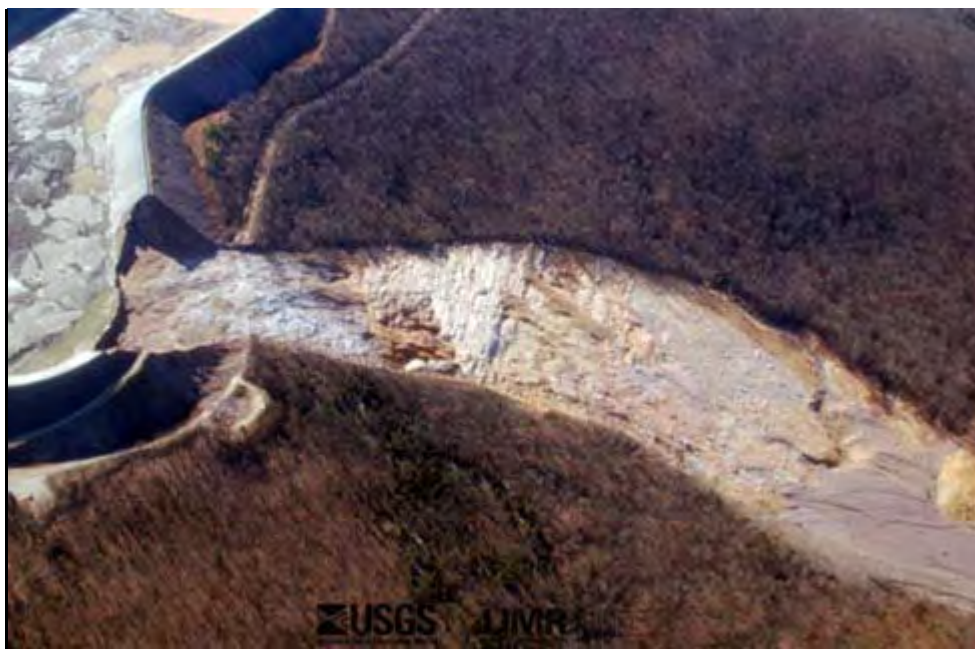
Figure 2.18. View of emptied lake and vicinity.

Figure 2.18 shows a closer view of the emptied lake and breach vicinity. In this case the lake wall was overtopped and also suspected of being undermined by seepage. When it collapsed, the lake was emptied in a matter of 12 to 15 min. It is suspected that the 17th Street breach in New Orleans failed catastrophically after some initial period of overtopping as well. Knowing that such documented cases exist, for this study a worst case scenario was considered as an instantaneous removal of the levee wall, allowing flow to cascade out of the breach.

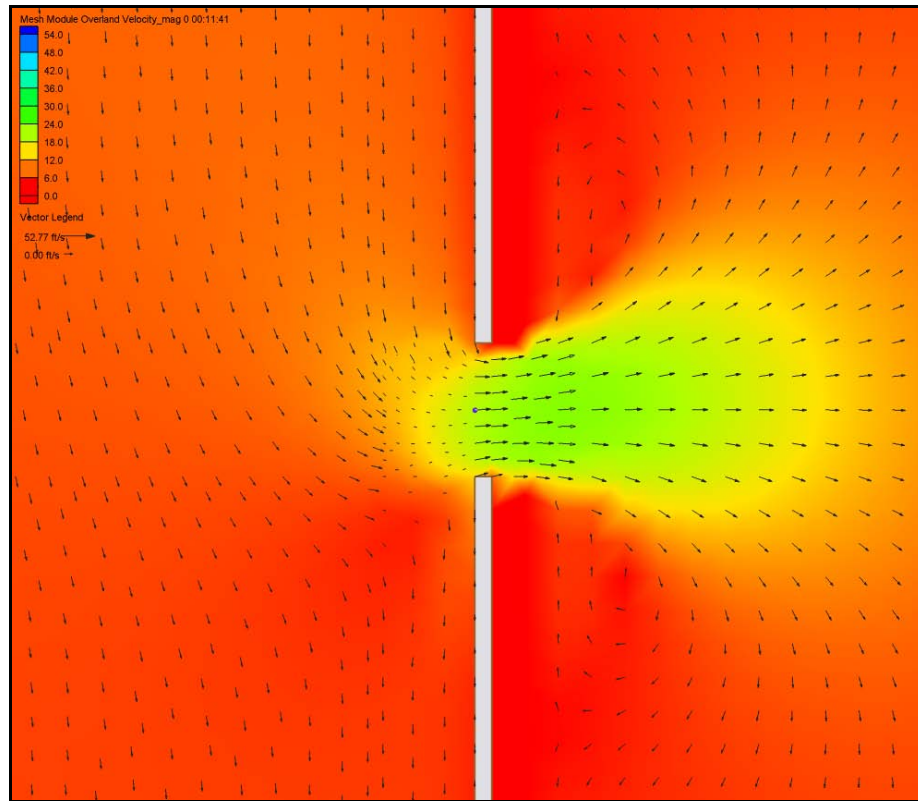
Figure 2.24. Force vectors (assuming a drag coefficient value of 2) for flow through an idealized breach.

The emphasis so far has been on the absolute highest velocities and forces occurring in the simulation. However, an object placed upstream of the breach would not necessarily encounter the highest velocities. It is also necessary to consider the direction of velocity in a lateral levee breach. As can be seen in Figure 2.24, the complete velocity vector can have a significant component in the streamwise direction that could seriously affect the effort to position the closure device. For example, at the centerline of the breach opening and about 150 ft from the levee crest on the river side of the breach, the component of velocity in the breach direction is 9.5 ft/s and the streamwise component is 3.3 ft/s. At the same distance from the levee crest but at the north abutment, the component through the breach is 2.6 ft/s and the streamwise component is 7.7 ft/s. So in moving a closure device a distance of only 100 ft in the streamwise direction and being 150 ft away from the levee crest, the velocity components change from 66% streamwise and 33% breach direction to 66% breach direction and 33% streamwise. This shows clearly that the streamwise components of velocity cannot be ignored when considering the logistics of moving a closure device into place, which will become a very important topic when discussions for the concepts of operation for deployment are being developed.

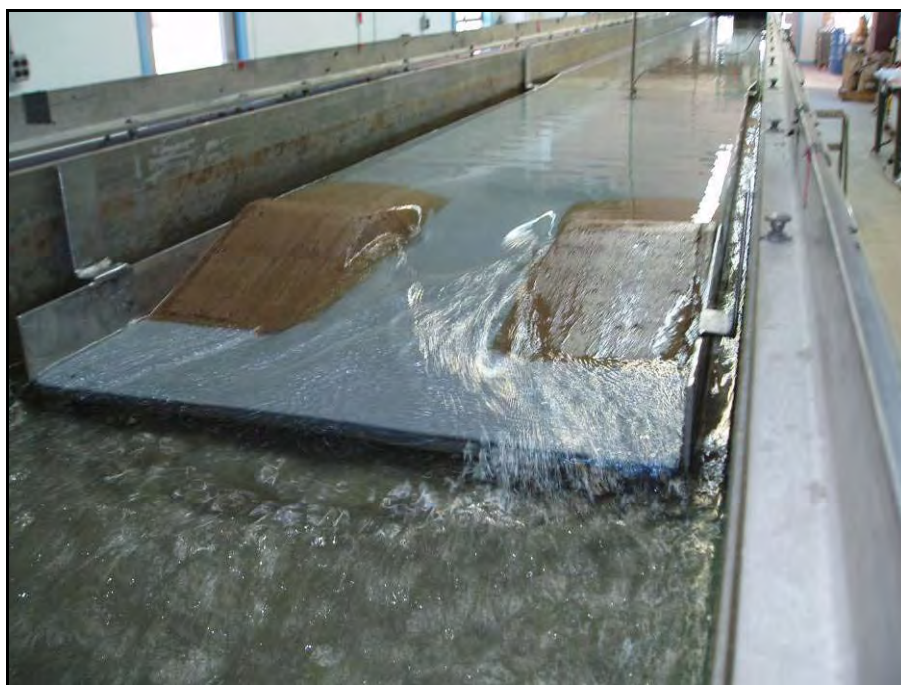
Figure 2.25. Photo of flow through small-scale (1 : 50) breach.

An 80 ft long tilting flume was used to provide a simulated levee breach and flow for testing the various closure methods discussed above. The flume cross section is 3 ft wide and 1 ft deep. The facility has pumps that can supply up to 5.5 ft³/s of flow capacity. To maintain a constant water level during the closure tests, a special side-weir-overflow device was constructed to fit within the flume. A simulated levee was constructed separately but made to fit exactly within the confines of this overflow device. The flume, overflow device, and simulated levee are all shown in Figure 2.25.

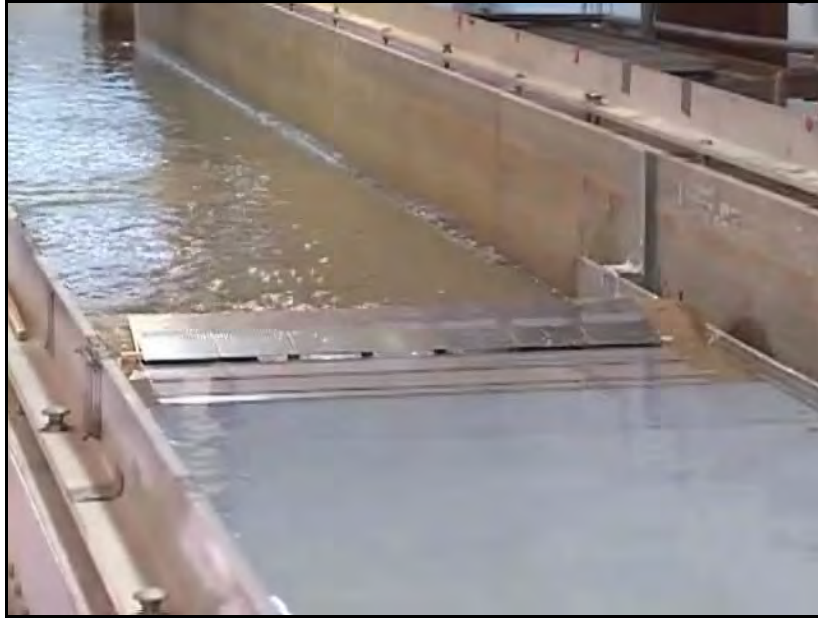
Figure 2.26. Photo of gated structure test in 1 : 50 scale flume.

1. Rectangular gated structure floated into place, with and without a tarp. Figure 2.26 shows the gated structure just after placement with gates still open. After gate closures, significant flow continued along the device perimeter. A tarp was used in combination with the gated structure to see how this would work in conjunction with it. The slow residual velocities allowed positioning of the tarp and actually helped move and seal the tarp against the structure. The result was an almost complete reduction of flow through the breach as shown in Figure 2.27.

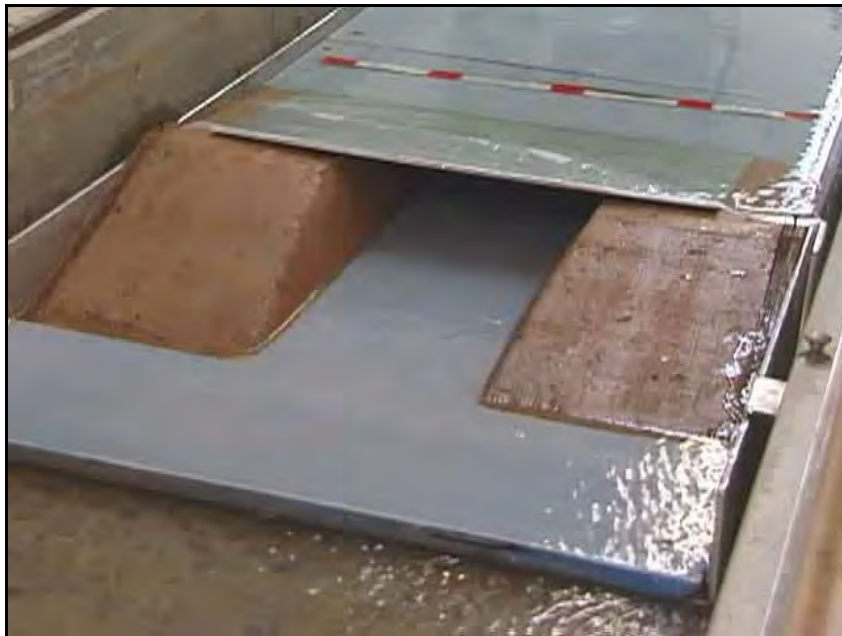
Figure 2.27. Test of a gated structure combined with a tarp showing almost no residual flow.

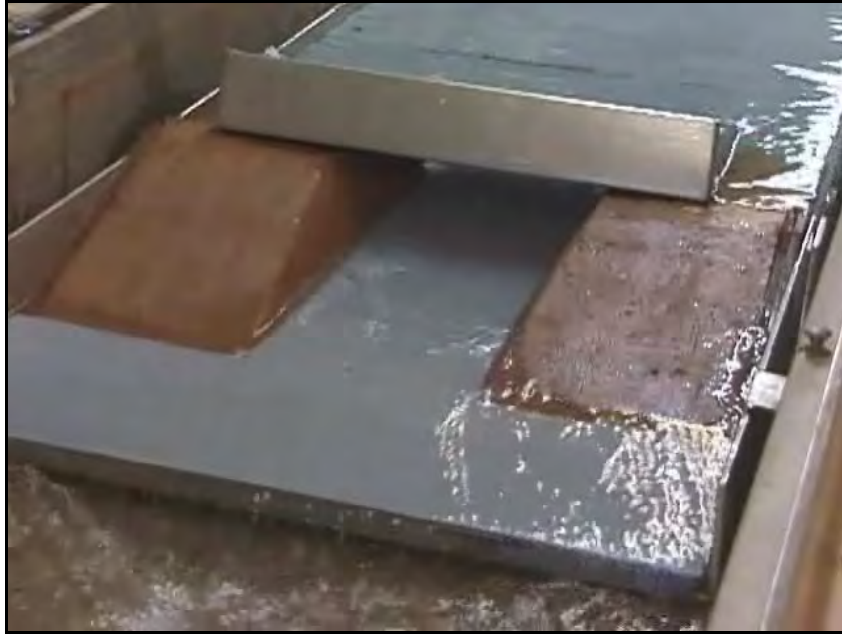
Figure 2.28. Idealized barge floated into position on small-scale levee and ballasted with water.

2. Barge floated into place with ballast on one side. A sealing fabric bag was added on the upstream side of the barge. Figure 2.28 shows the barge driven up the levee embankment with a simulated fabric bag placed against its upstream side. Significant flow reduction occurred.

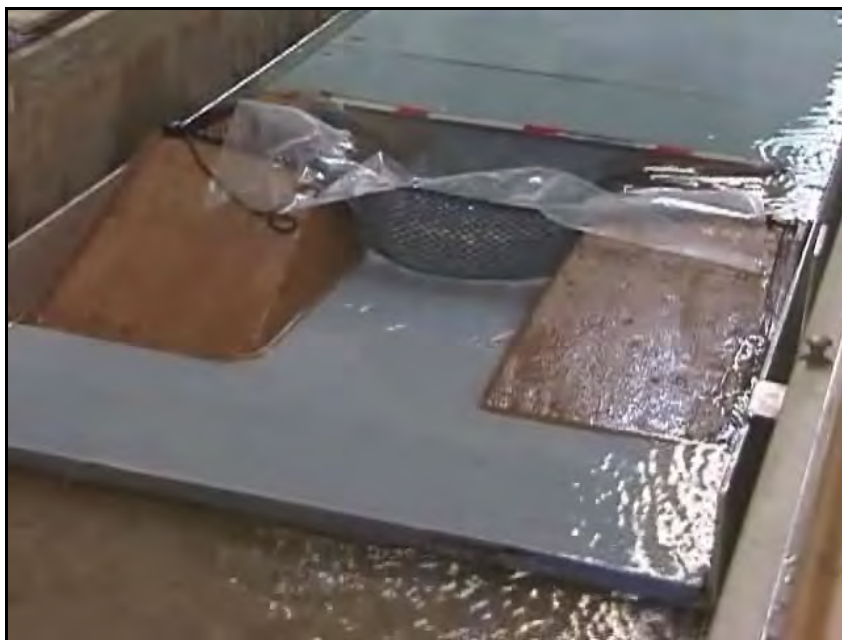
Figure 2.29. Photo of performance of a net anchored on either side of a breach combined with a tarp.

3. Simulated cable net placed over the breach with tarp placed upstream of the breach. This is shown in Figure 2.29.

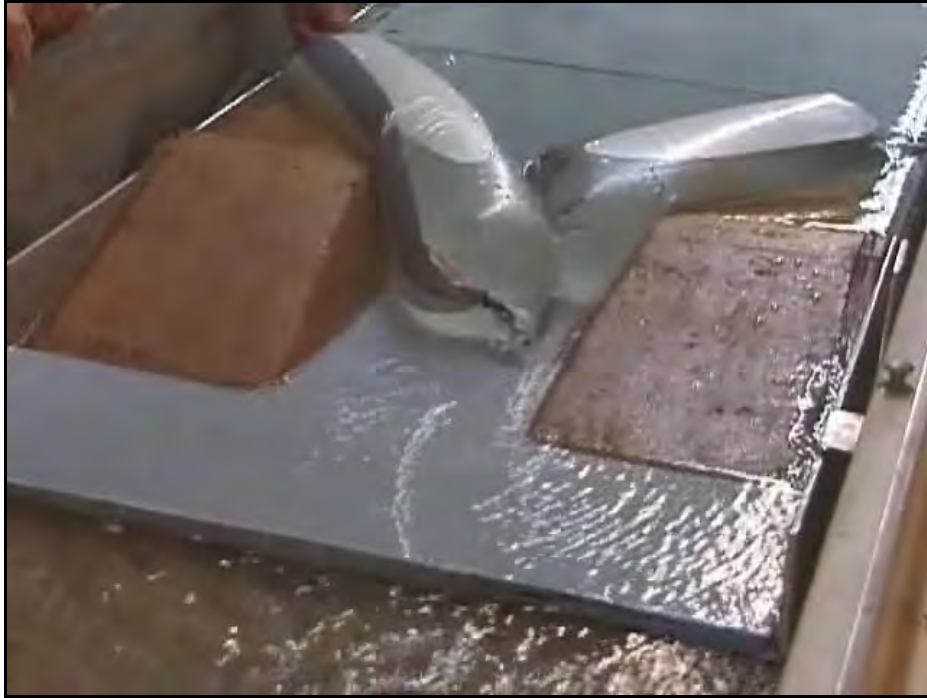
Figure 2.30. Photo of water-filled tube concept using two tubes anchored to either side of a breach in the 1 : 50 scale model basin.

4. Geotextile fabric bags filled with water. For these tests, water-filled plastic bags were tested in anchored and unanchored configurations. Bags anchored on each end and filled in place are shown in Figure 2.30.

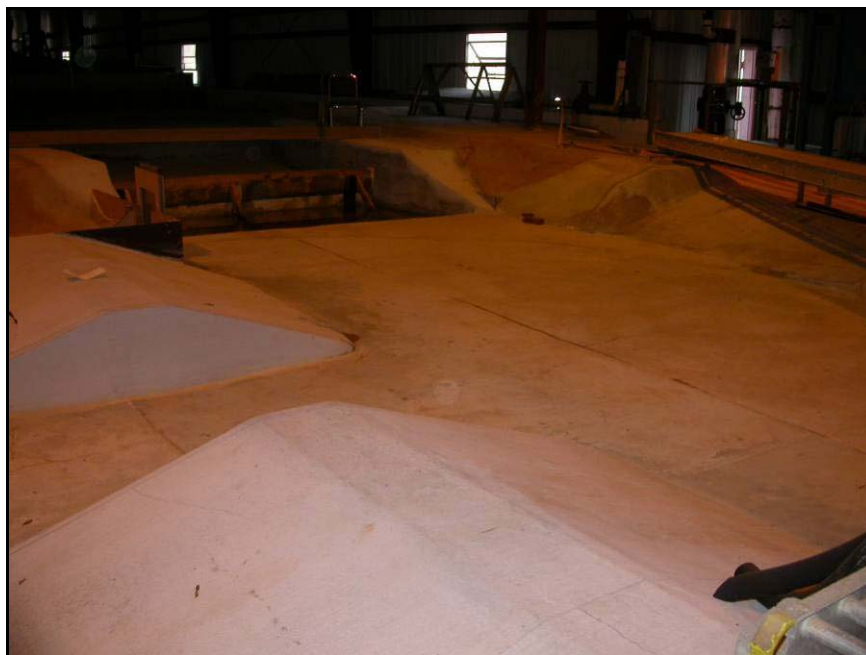
Figure 2.31. Test basin for 1 : 16 scale physical model tests.

During the early phase of this project we investigated a wide range of ideas of potential value to rapid levee repair; but many of those ideas were soon recognized as either impractical or beyond the state of the science that exists today. We knew that we could not continue to devote extensive amounts of time to all of these different ideas and still meet our specified timelines for large-scale demonstrations. To assist us with our down-selection, we knew that it would be extremely useful to have a physical basin that was substantially larger than the 1 : 50 scale flume described previously in this report. An existing physical model facility within ERDC was identified as having the best potential for providing a suitable basin for such testing of RRLB concepts. This basin was modified from its initial purpose to provide a flow capacity consistent with a 1 : 16 scale along a levee section (Figure 2.31). The model levee was constructed at an undistorted scale and represents a levee with a crest elevation of 20 ft (note: all dimensions are reported in prototype scale unless otherwise stated), side slopes on both faces of 1 : 3 (vertical : horizontal), and a crest width of 16 ft. The breach was 80 ft wide with 2 : 1 side slopes the full depth of the levee. Both the model basin and the levee were constructed of a concrete cap poured over a sand fill with inset aluminum templates to ensure the accuracy of the bathymetry and topography.

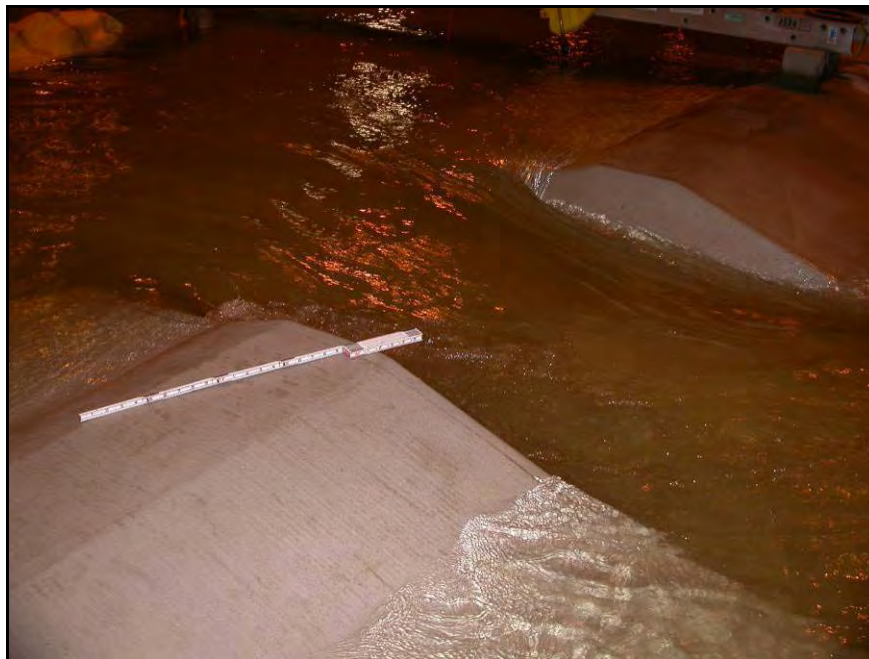
Figure 2.32. Flow through the breach with upstream depth at 18.7 ft.

This model represents a fairly extreme test for breach closure because the breach is 80 ft wide and 20 ft deep, the still water level is 18.7 ft deep, and there is a significant riverine current flowing along, past, and through the breach (Figure 2.32).

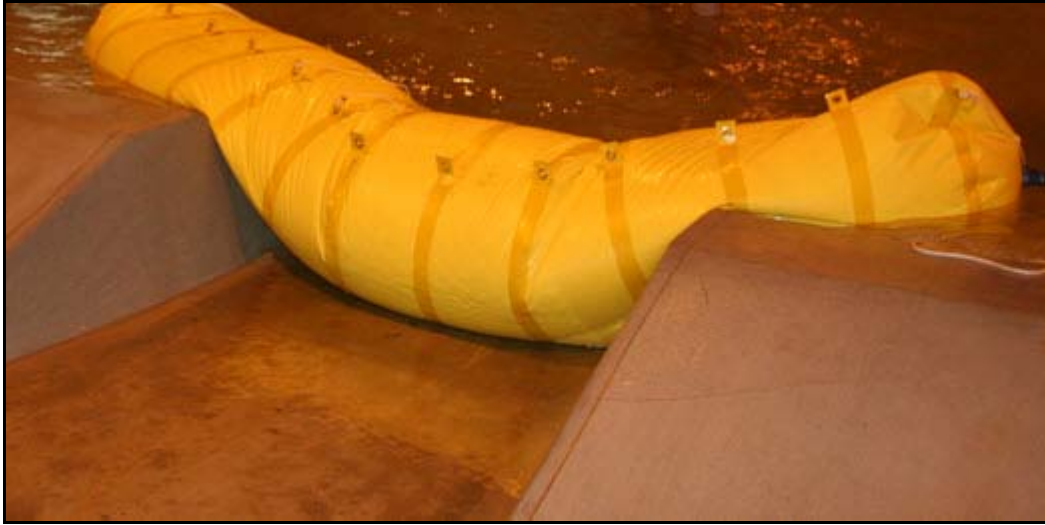
Figure 2.35. Deep-breach closure with large tube filled to 60% fill volume.

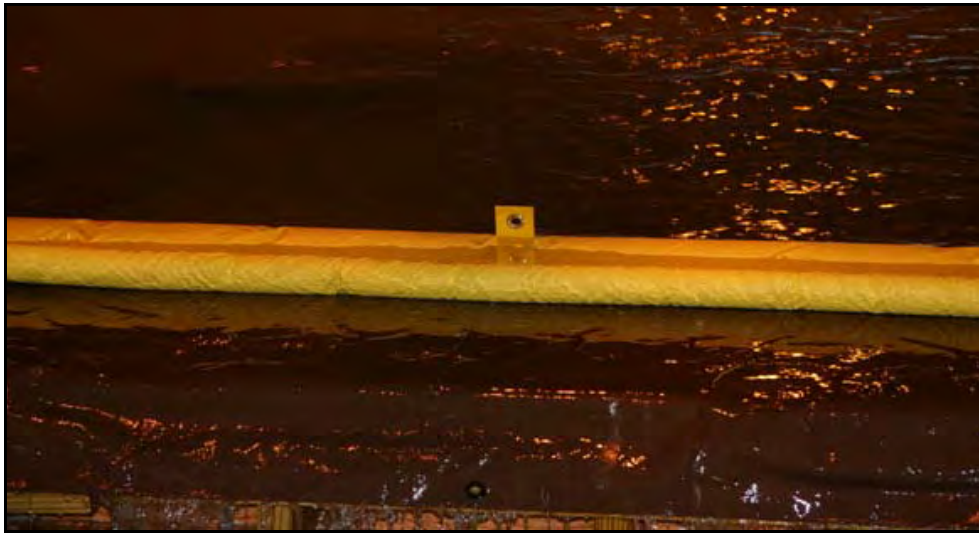
Figure 2.36. Performance of a very long water-filled fabric tube in a wide, shallow breach test in the 1 : 16 scale model.

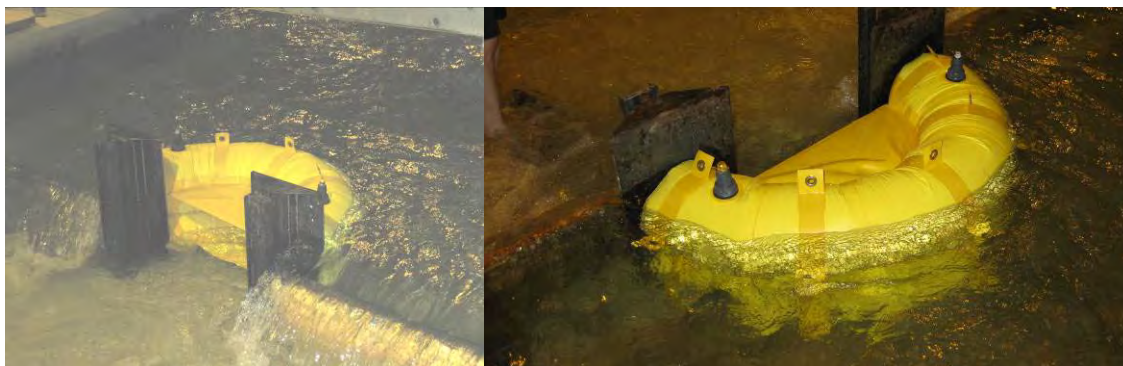
Figure 3.1. Successful laboratory tests of a two-arch system for blocking flow through a simulated “gate” opening. Actual distance spanned by the ARCH in these tests is about 1.5 ft.

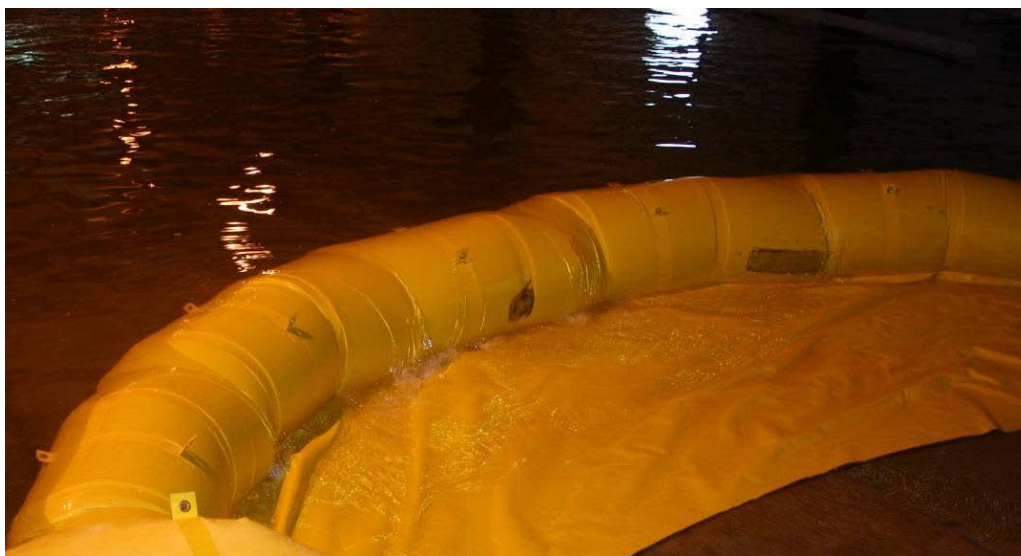
Figure 3.2. Successful small-scale test of a single-arch system for blocking flow across a large open area. The actual distance spanned by the ARCH in this test is about 25 ft.

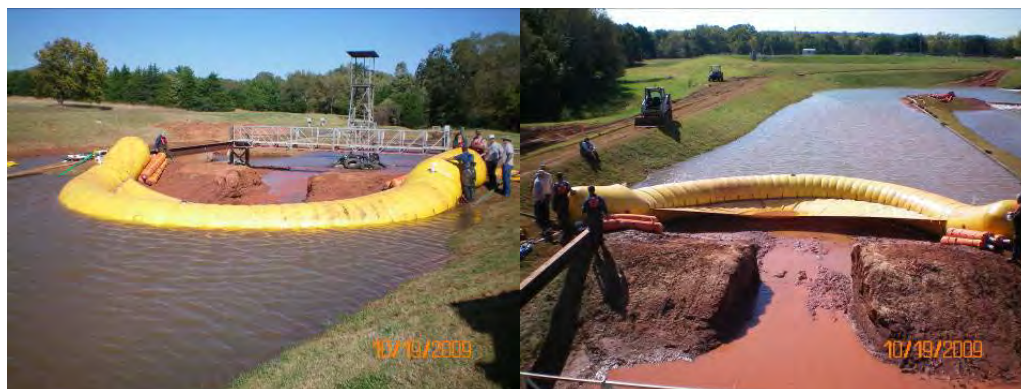
Figure 3.3. Early tests of the ARCH showing its ability to seal the area around a breach to allow the PLUG to be emptied and removed before permanent repairs commence.

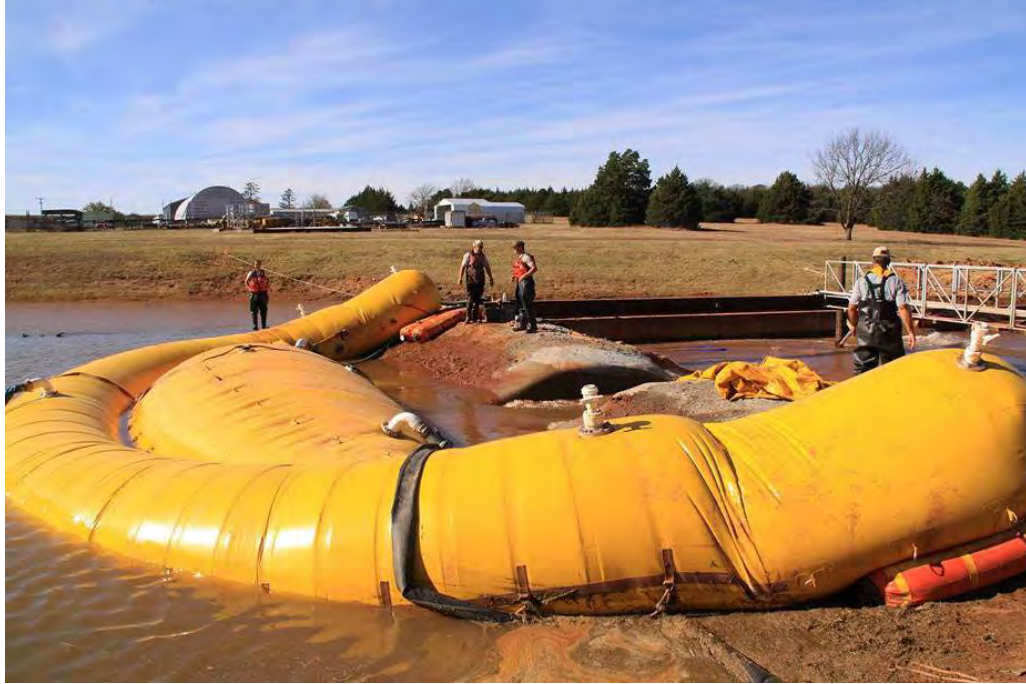
Figure 3.4. Test of the modified ARCH system at Stillwater, Oklahoma, in November 2009. The ballast tank seen behind the apex of the ARCH improved its ability to resist deformation under very high water levels.

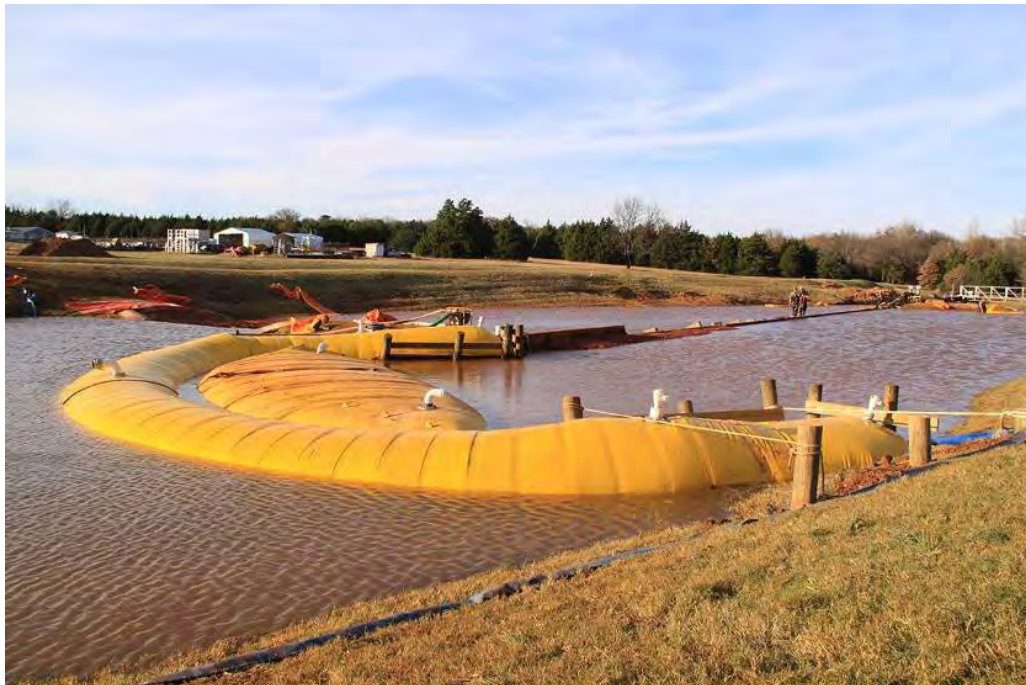
Figure 3.5. Test of the modified ARCH at Stillwater, Oklahoma, in November 2009 showing its ability to block water from flowing into a channel about 40 ft wide with a water depth of about 4 ft.

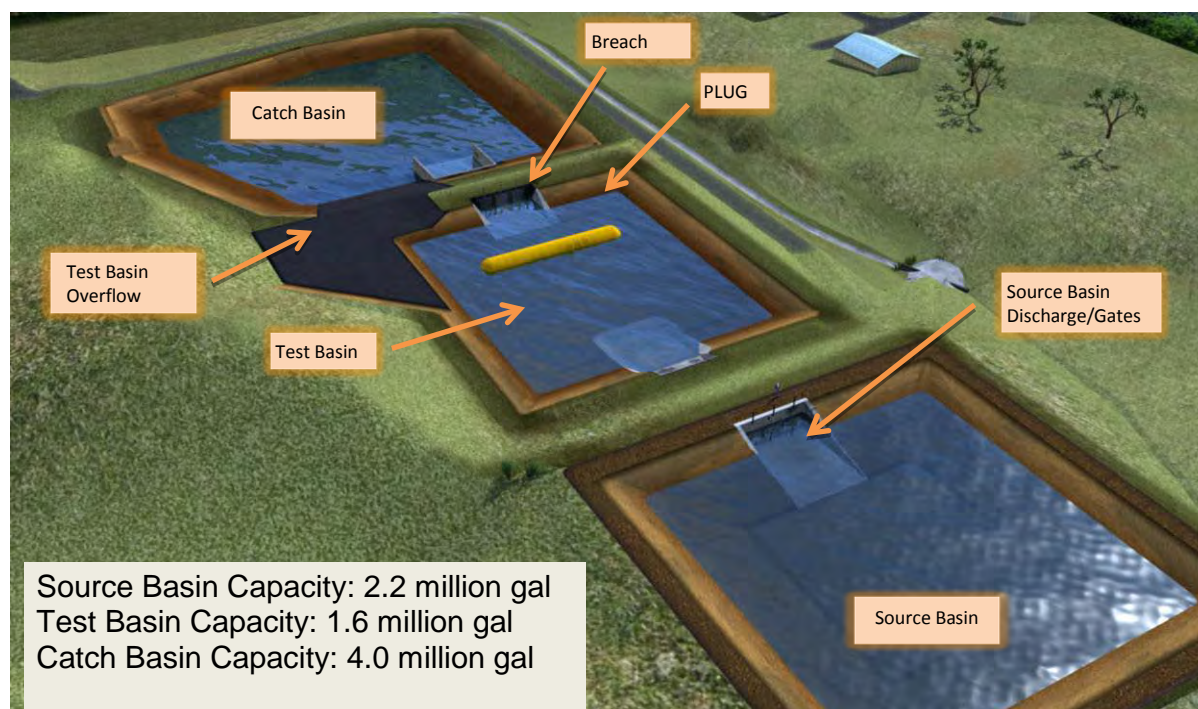
Figure 3.6. Artist's rendition of the three-basin full-scale test facility.

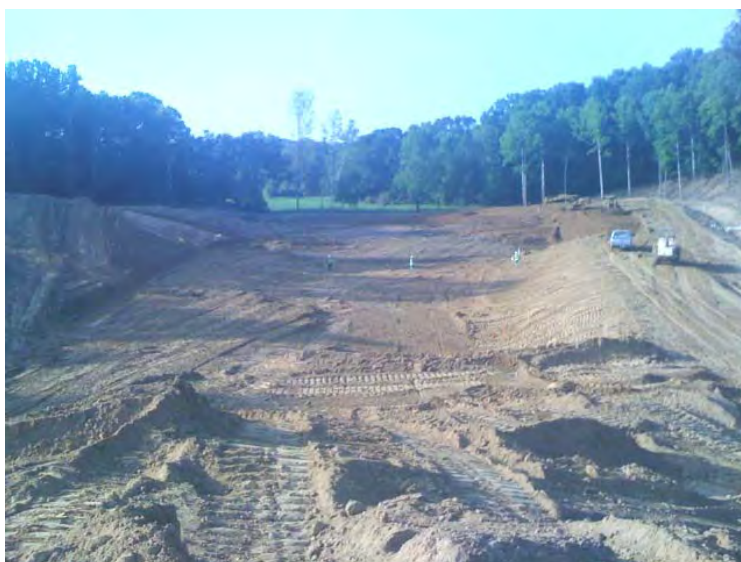
Figure 4.1. Early stage of construction July 2010.

Construction work began at the test model on June 14, 2010 (Figure 4.1). Construction of the test model comprised three major activities, earthwork, structures, and subsystem installation.

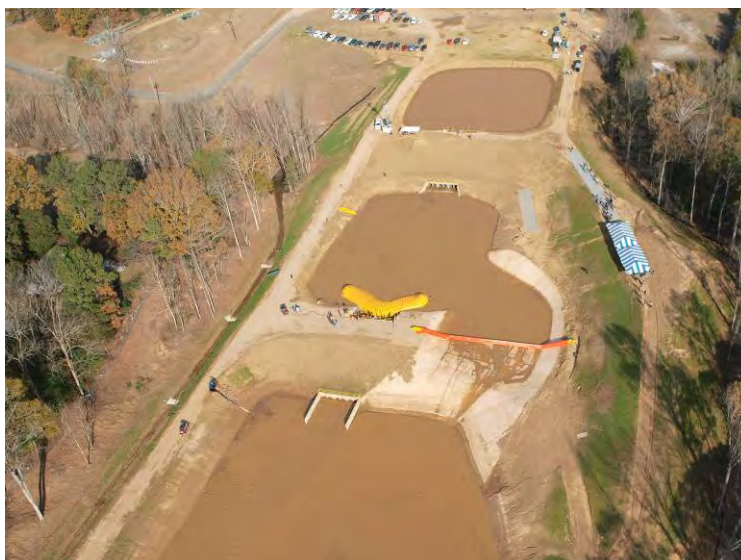
Figure 4.2. Aerial photograph of full-scale test basin, December 15, 2010.

Construction was substantially complete on October 25, 2010, following two successful acceptance tests. Figure 4.2 shows an aerial photograph of the full-scale test facility taken during the PLUG demonstration on December 15, 2010.

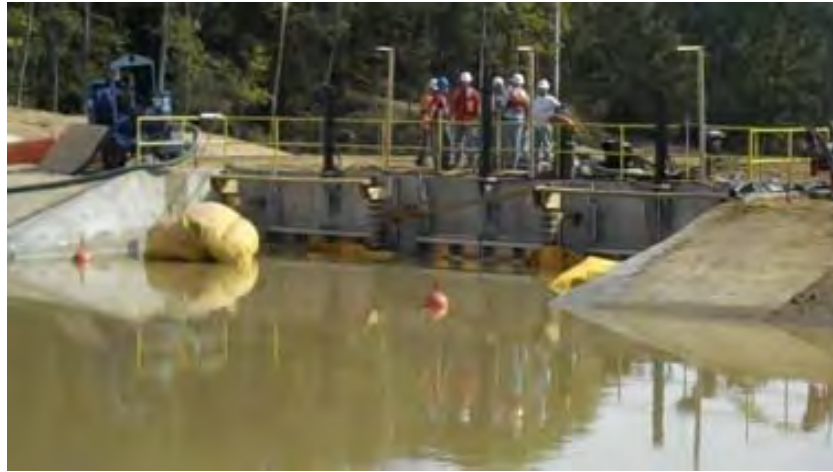
Figure 4.3. First PLUG test culminated in a failure, with substantial damage to the gate protection system and tears to the PLUG.

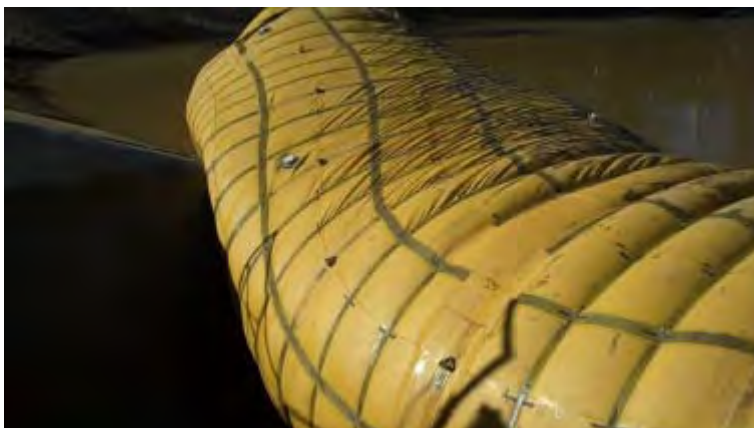
Figure 4.4. Successful test of the PLUG which achieved almost 100% stoppage of flow. The view in this figure is from the downstream side of the breach, with the water that is being held back from the breach shown in the upper right.

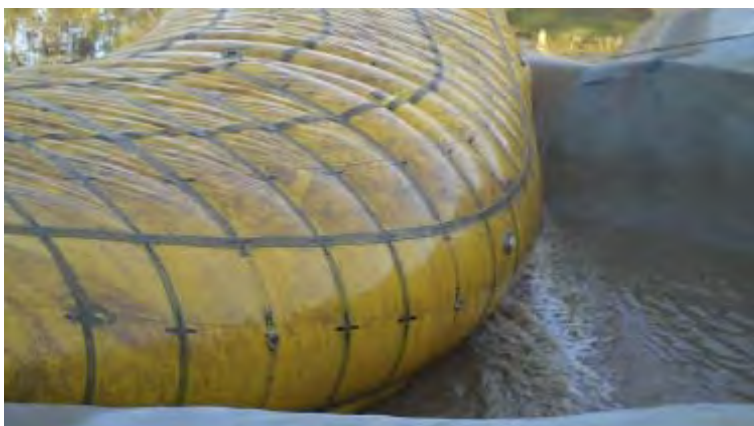
Figure 4.5. Photograph of the same test result as shown in Figure 4.4, except that it is taken from the opposite side of the breach. The curvature of the tube can be clearly seen along with rotational distortion in the longitudinal straps.
